Georgetown Green Communities weatherization projects 2020

Georgetown MA

Building Envelope Inspection Report

October 31, 2019

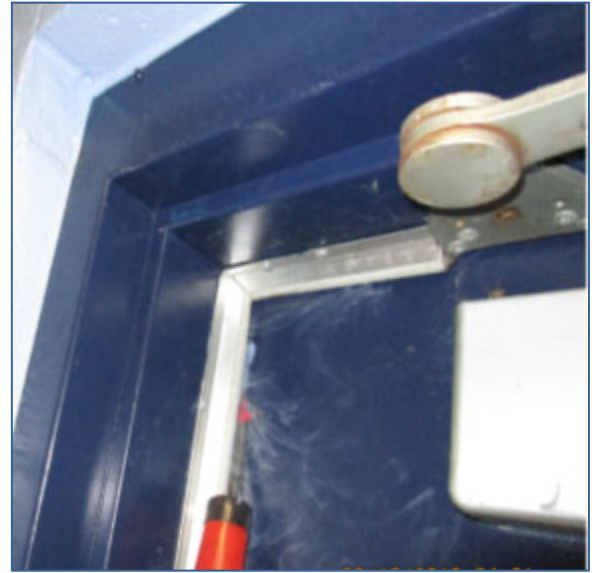
Right: MS-HS – tracer smoke testing along the exterior doors identified significant air-leakage, due to failing weatherstrip. Note the smoke being blown back into the conditioned building space, indicating considerable air infiltration. New weatherstrip needs to be installed on the exterior door systems.

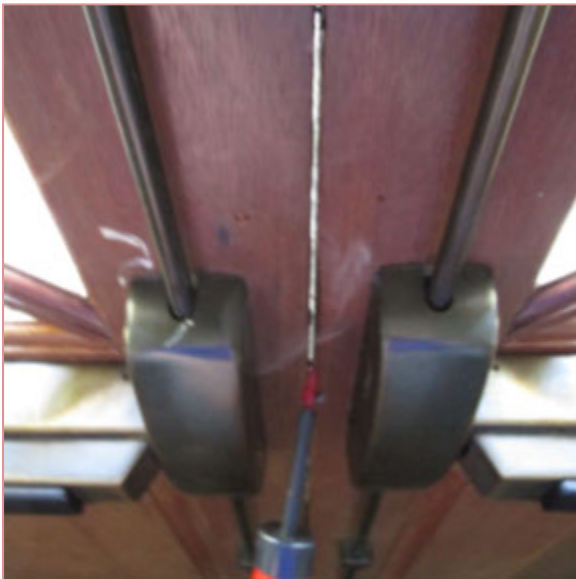
Left: Town Hall – photo shows tracer smoke test being performed along exterior double-door system. Note the large (1/4") gap, with daylight peering through along the center, and the smoke being blown back into the building. This signifies sizable air and moisture infiltration through the building envelope. New weatherstrip needs to be installed on the exterior door systems.

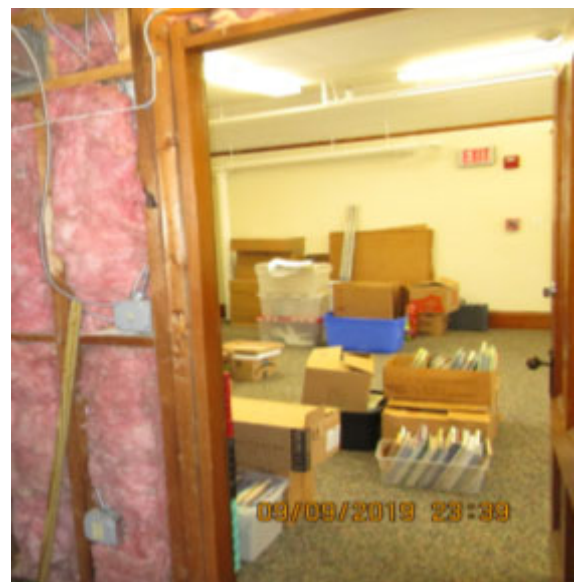
Right: Peabody Library – the doors (third floor) leading to the attic spaces behind the knee walls are effectively exterior doors. These doors lack weatherstrip and, as such, need weatherstrip installed.

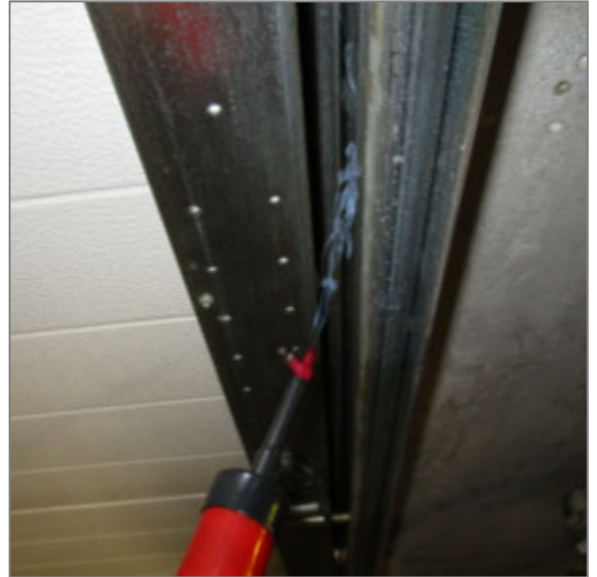
Right: Highway Dept. Bldg. #2 – tracer smoke testing along the overhead doors indicates substantial air-leakage. Note the smoke being pulled out of the building's conditioned space, representing ongoing heat loss during the heating season and heat, moisture, and outdoor pollutant infiltration during the spring, summer, and early fall seasons. New, durable weatherstrip needs to be installed on the overhead door systems in both buildings.

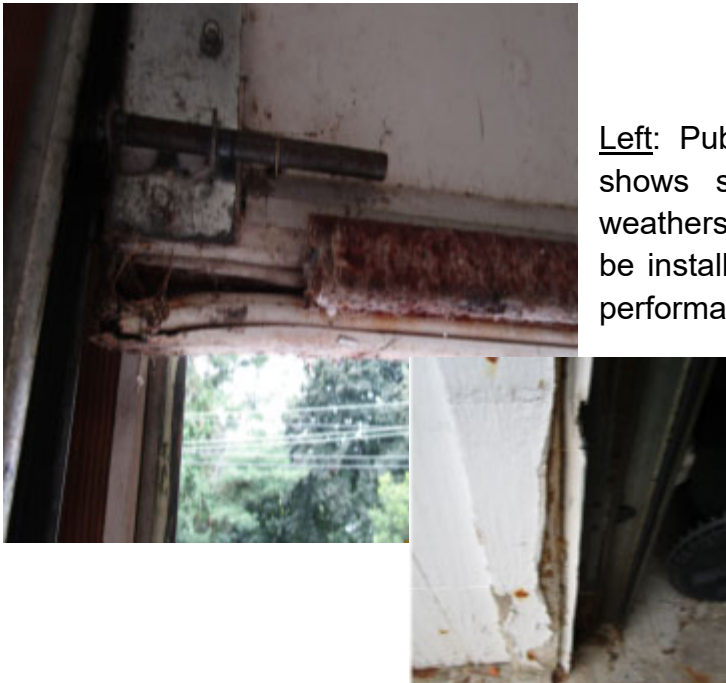
Left: Public Safety – the overhead door system shows significant signs of deterioration of its weatherstrip. New, durable weatherstrip needs to be installed on each of the doors to improve their performance and that of the building overall.

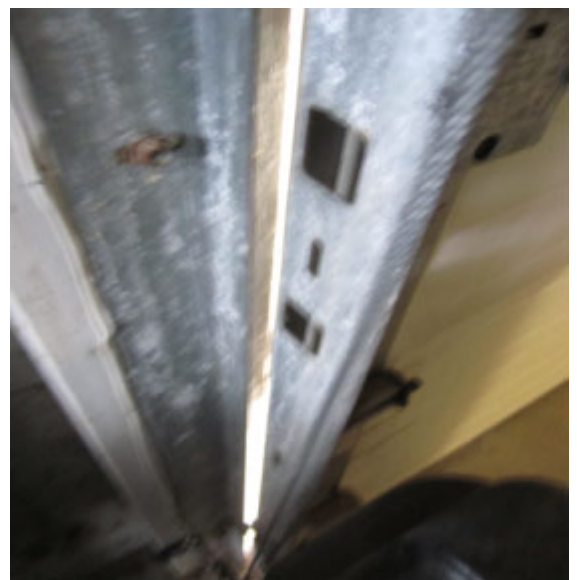
Right: Municipal Light Dept. – note the daylight showing through the edges of the overhead door. These large gaps are due to failing and/or missing sections of weatherstrip. New, more durable and effective materials need to be installed on the overhead doors at the two Light Dept. buildings.

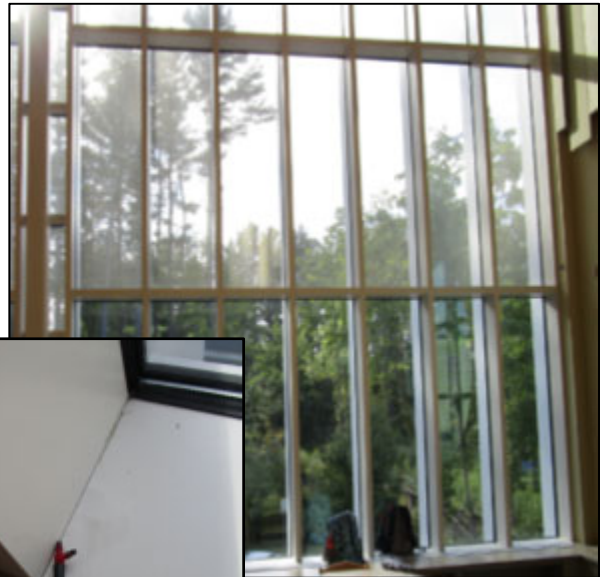
Right: Penn Brook E.S. – photo shows one of the many large, fixed windows throughout the school. Testing indicates that most of these are leaky along the mullion details at the corner seams (insert). Each of the large window systems (library, stairwell landings, etc.) need to have these details air-sealed using non-foam sealants.

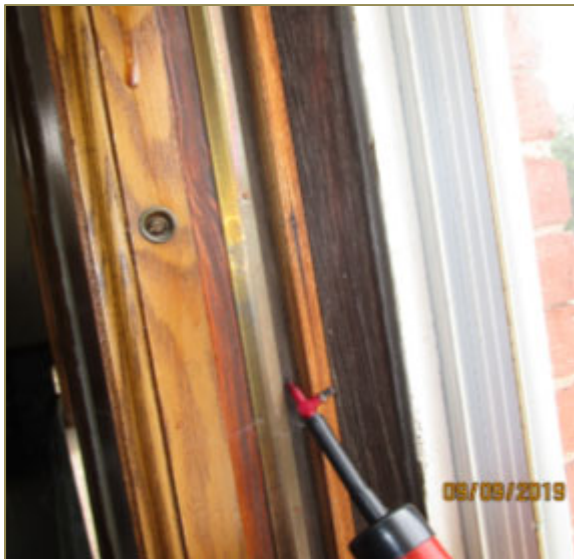
Left: Perley School – testing along the window systems identified significant air-leakage, due to failures with the existing weatherstrip. New weatherstrip needs to be installed along the sashes and meeting rails to tighten these units, alleviating drafts and improving occupant comfort and the energy performance of the windows.

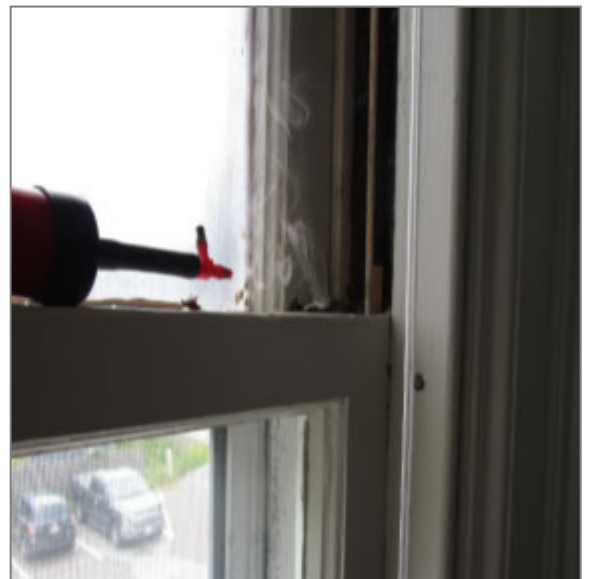
Right: Town Hall – smoke testing along the wood, double-hung windows indicates air-leakage, partly due to some shrinkage in the wood framing, but mostly due to failing or missing weatherstrip. New weatherstrip (including sash locks and pulley seals) needs to be installed on the wood-framed and metal-framed windows basement sections.

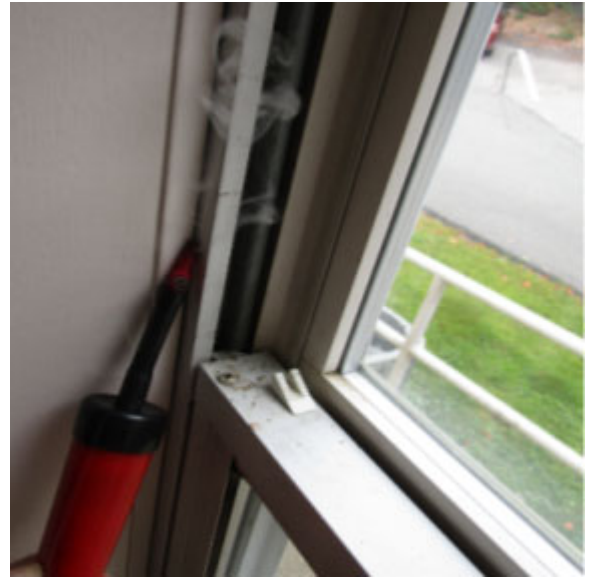
Right: Public Safety – tracer smoke testing along the frame-wall junctures. Note the smoke being blown away from the seam and back into the conditioned space, indicating significant air-leakage that bypasses the window. These leakage paths allow for drafts and enable outdoor humidity and pollutants (e.g. pollen) to enter the building. These frame-wall junctures need to be air-sealed using non-foam sealants.

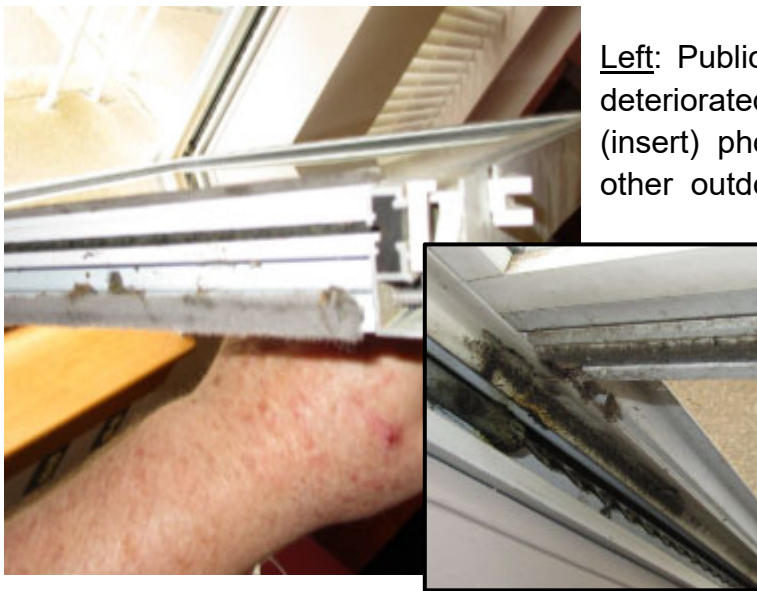
Left: Public Safety – photo shows example of the deteriorated weatherstrip on the windows. The (insert) photo show the dirt, insect remains, and other outdoor pollutants that enter through these air-leakage paths into the building, lending to poor occupant comfort and IAQ. New weatherstrip needs to be installed to alleviate these drafts and improve occupant comfort and IAQ.

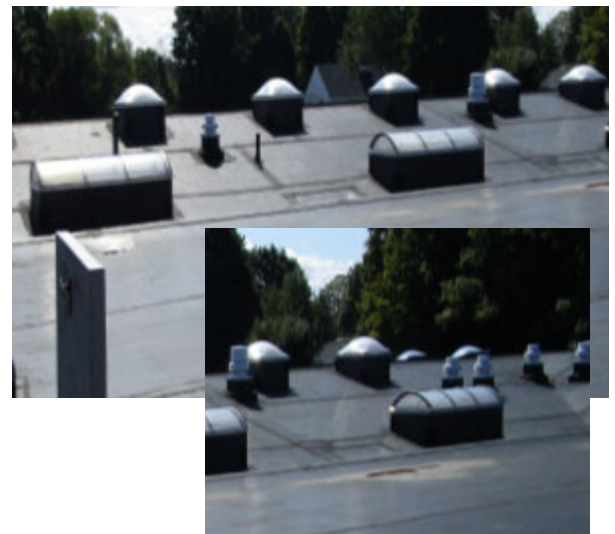
Right: Perley School – the photos show the square and rectangular skylights and roof-top fans along the flat roof. The skylights and fans connect the outdoors directly to the conditioned spaces below, due to sealant failures and framing details along the curbs and fan chases. The skylights and fans need to have these air-leakage paths sealed.

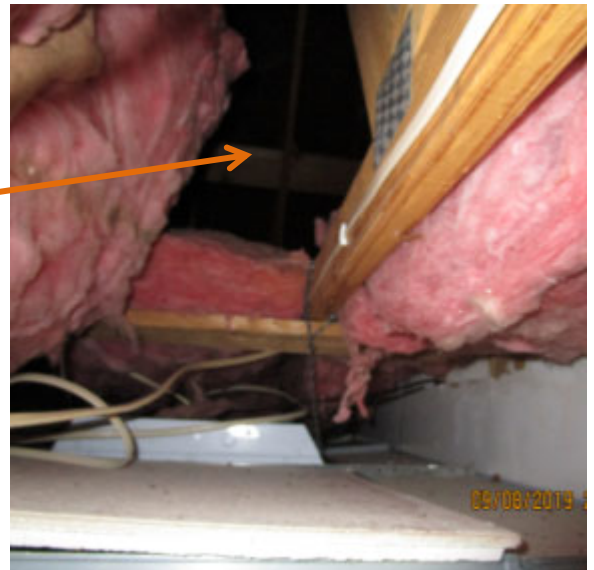
The sloped wood roof, with truss framing, has no insulation. The roof assembly has soffit and ridge venting. There is R-30 batt insulation fitted within the bottom of the truss framing. There is essentially no air barrier in place, allowing ongoing heat losses (during heating season) and air, moisture, and pollutant infiltration during the spring, summer, and early fall. A rigid air barrier needs to be installed on the bottom of the truss framing, above the suspended ceiling, using 1" fire-rated board insulation, sealing all seams and penetrations. The working height to the bottom of the truss framing is 10'. The bottom of the truss is approximately 10" above the suspended ceiling.

Right: Light Dept. Office – the photo shows the truss framing, with batt insulation fitted within the framing directly over the suspended ceiling. Looking through the void, you can see the **underside of the sloped wood roof deck**. There is no effective air barrier between the building's conditioned spaces and the attic/outdoors. An effective air barrier needs to be affixed to the underside of the truss framing, creating aligned air and thermal barriers and improving occupant comfort, IAQ, and the overall energy performance of the building.

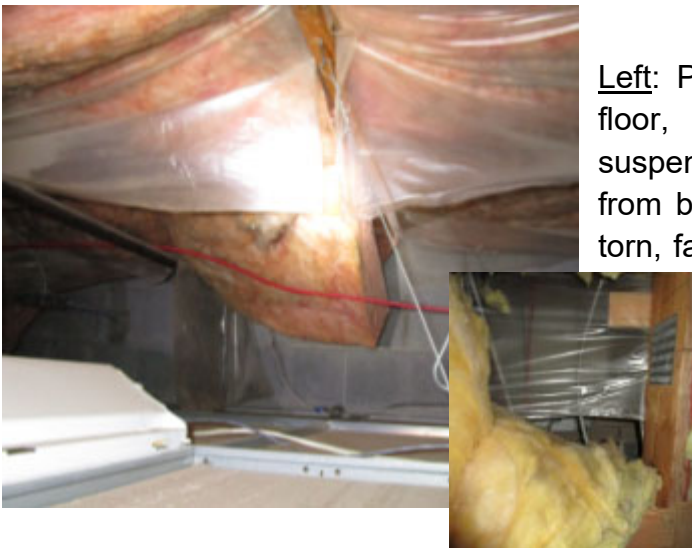
The sloped wood roof sections have no insulation. In a large section of the second level, there is no effective air barrier in place, merely batt insulation fitted within the truss framing (with second layer atop) and a thin poly liner stapled to the bottom of the framing. There are torn, missing, and deteriorated sections of the poly throughout. A rigid air barrier needs to be installed on the bottom of the truss framing, above the suspended ceiling, using 1" fire-rated board insulation, sealing all seams. The working height to the bottom of the truss framing is 12'. Install an air barrier, per the QAS manual and floor plan.

Left: Public Safety – throughout most of the upper floor, there is no effective air barrier above the suspended ceiling. Note the batt insulation falling out from between the truss framing, and the thin plastic torn, fallen, and missing in sections. The insert photo shows the same detail from the attic side. As with the Light Department, an effective air barrier needs to be installed above the suspended ceilings to establish and align effective air and thermal barriers.

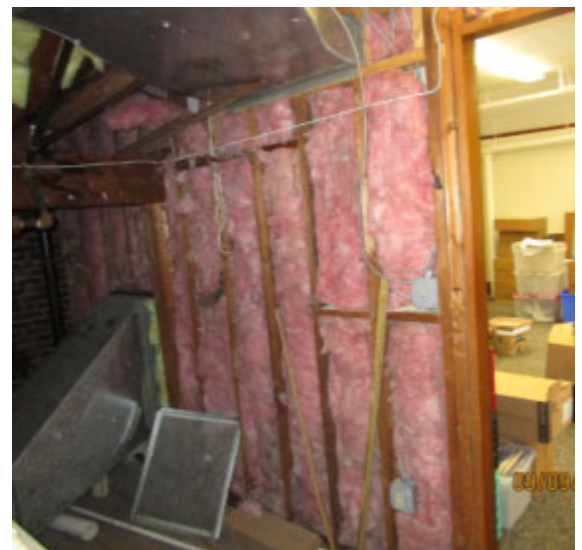
Right: Library – photo shows a section of the knee wall, which is essentially an exterior wall, as it separates the third floor's conditioned space from the unconditioned attic area. The insulated wall is very leaky (note the large duct penetrations) and has no effective air barrier. A rigid air barrier needs to be installed, affixed to the knee wall framing and sealed to improve the energy performance of the walls and occupant comfort within the conditioned space.

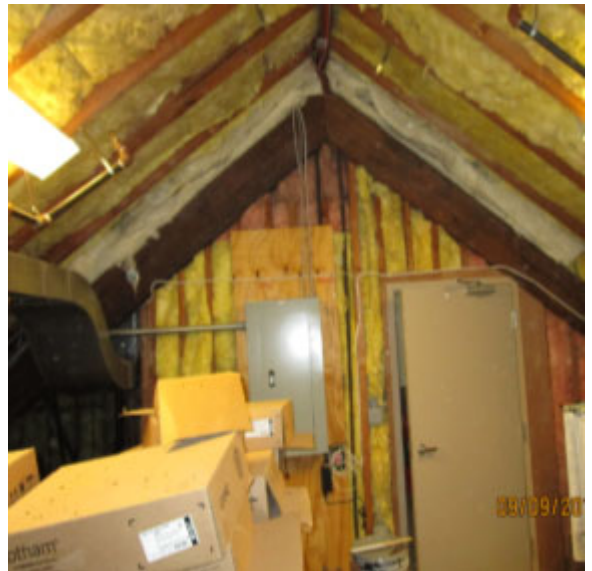
Right: Library – Along the other side of the original building, the attic/storage area is conditioned space (below, heating vent). Here, the insulated roof deck needs to have an effective air barrier affixed to the underside of the deck framing, covering and improving the performance of the existing insulation. This will effectively align the air and thermal barriers, bringing the conditioned space into the building envelope and improving the condition of the space and overall energy performance of the building.

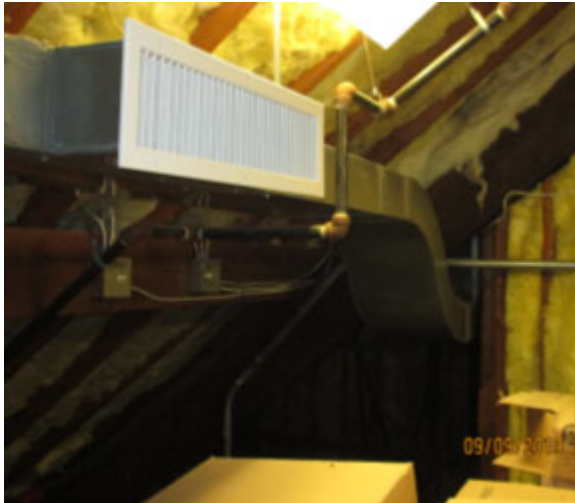
Left: Library – the heating duct/register conditions the space used for storage of files, equipment, and other office materials. Without an effective air barrier in place, the performance of the existing insulation is dramatically reduced, and communication with the outdoors is ongoing. Installing an effective air barrier will greatly improve the performance of this space and that of the building overall.

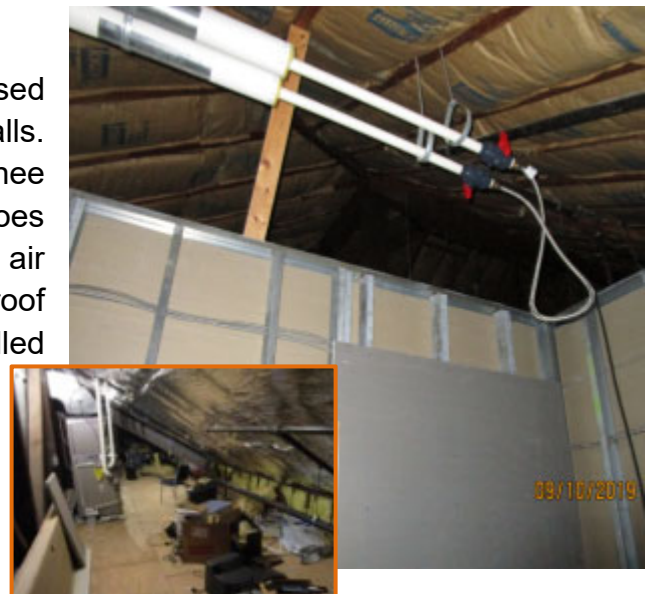
The attic is set up as conditioned space, with R-19 batt insulation (Kraft-faced) within the open framing of the roof deck. The wood-framed exterior walls extend 2' H above the floored attic framing. These walls have un-faced R-13 batts. The dormer walls are also insulated. None of the insulation has an air barrier.

Right: Town Hall – the center of the third floor is used for office space and is surrounded by knee walls. Because the thermal barrier is the roof deck, the knee walls do not need insulation. But the insulation does need an air barrier. To establish and align effective air and thermal barriers, the underside of the insulated roof deck needs to have an effective air barrier installed along the exterior walls, which extend 2' above the floor, to assure a continuous air barrier.
