Penn Brook Elementary School

Georgetown, MA

FEASIBILITY STUDY

Preliminary Design Program

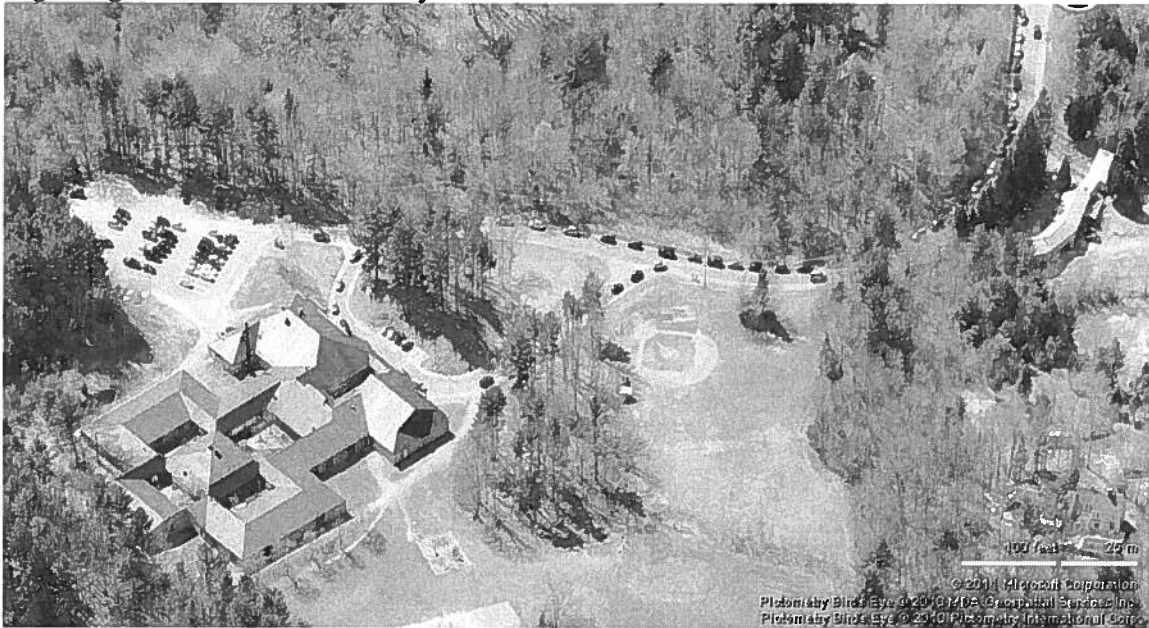
Aerial photo at pick-up time

At the Penn Brook School, during the pickup period there are many cars lined up along the entrance drive, and sometimes backing up onto Elm Street. Two hundred cars per day are estimated to come to the site this year (2011). Car and bus traffic is separated as vehicles circulate around the two outer lanes in the parking lot. The buses queue along the sidewalk facing the school at the north edge of the parking, and the cars proceed to the front canopy of the school to pick up students (see the accompanying diagram).

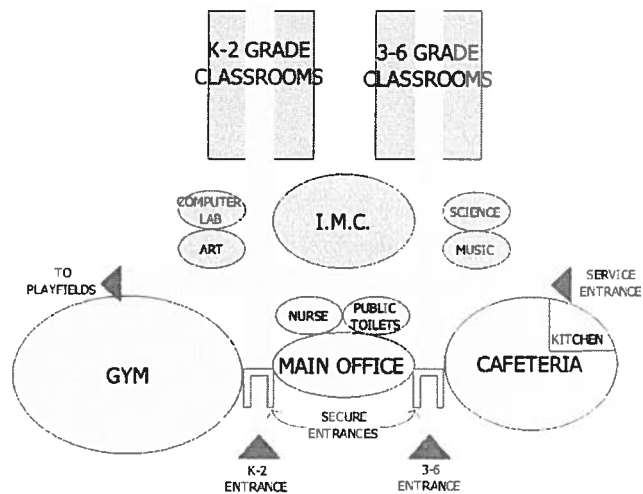
Spatial Relationship Diagram

There is a desire for the Gymnasium and Cafeteria and consequently the food service kitchen to be located in close proximity to a public entrance, the outdoor athletic fields, and located in such a way as to allow the remainder of the building to be secure during public events.

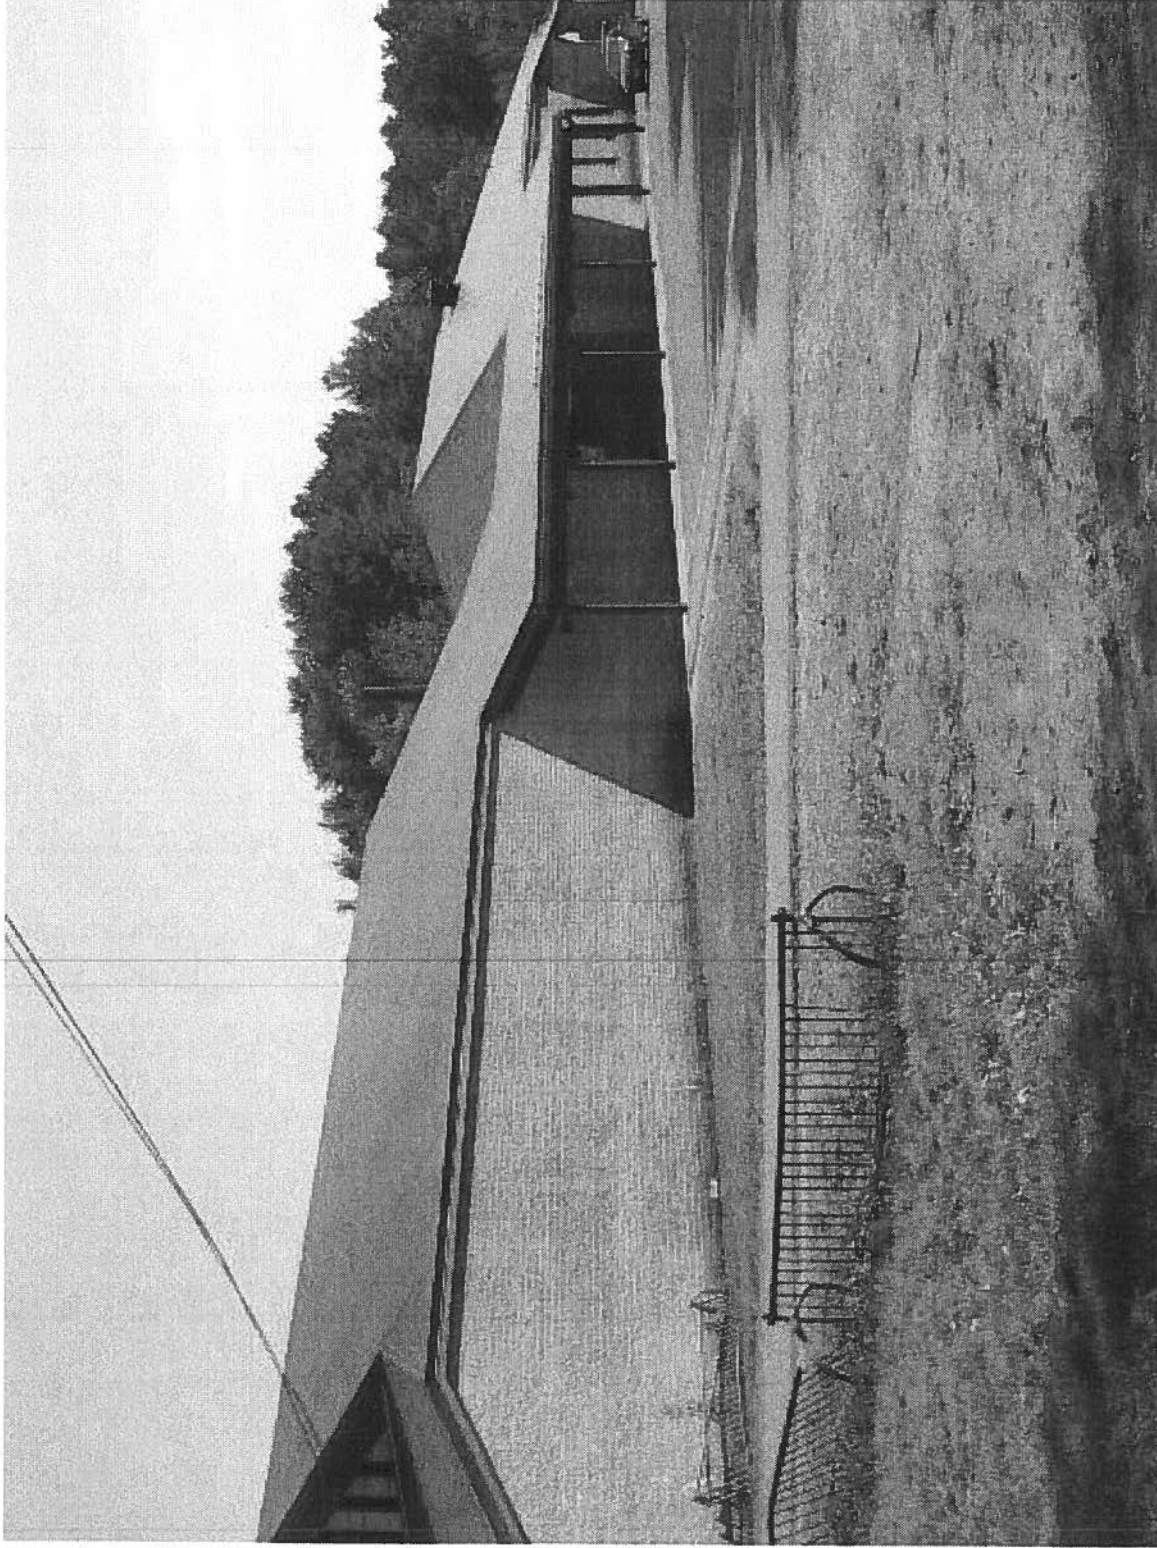
Front of building. Black EPDM roof. No concrete pad for bike rack.

- Original roof, shingles (either wood or composition asphalt) was replaced with adhered black EPDM rubber. The visual appearance is very poor, giving the building an unwelcoming appearance. The EPDM roof is also problematic in the fact that winter-time snow and ice does not adhere to the surface, and sheets off of the roof in a dangerous manner without warning. Temporary wooden sheds have been constructed over exit doors to protect persons from falling snow and ice. (There has been at least one incidence of a student being struck and injured.)
