Town of Georgetown

DESIGNATION GRANT FINAL REPORT

July 2021

1. TOWN HALL – WEATHERIZATION

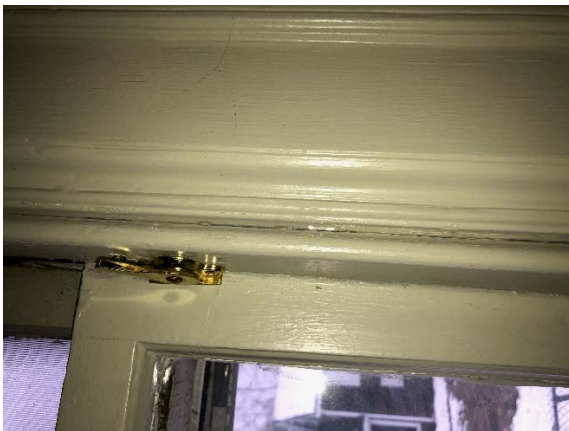
Town Hall Window Lock

- Weatherstrip the WAT-1, WAT-2, and WAT-3 units with spring-bronze kits, total 1,175 LF
- Air-seal the WAT-1 through WAT-5 units along frame-wall junctures, 1-line, using non-foam sealants, total 1,273 LF
- Install side-mount sash locks on the WAT-1, WAT-2, and WAT-3 units, total 62 windows/124 sash locks
- Install pulley seals on the WAT-1, WAT-2, and WAT-3 units (if there is no rope or chains in place, block the holes with non-foam sealant), total 62 windows/124 pulley seals

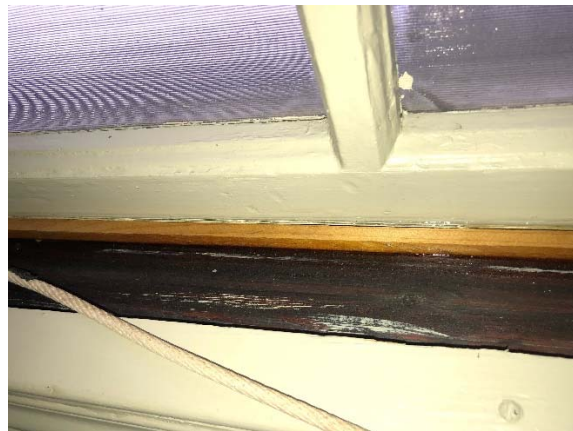
Town Hall Window Caulk

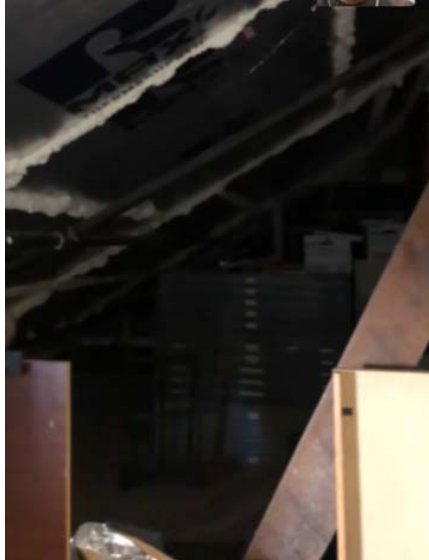
Town Hall Attic

- Install 1” rigid, fire-rated foam insulation to the underside of the sloped wood roof decks, sealing all seams, total 6,133 SF
- Install 1” rigid, fire-rated foam insulation to the interior surfaces of the two wood-framed dormer walls, sealing all seams, total 164 SF
- Install 1” rigid, fire-rated foam insulation to the interior surfaces of the exposed exterior walls (2’ above the attic floor), sealing all seams, total 564 SF

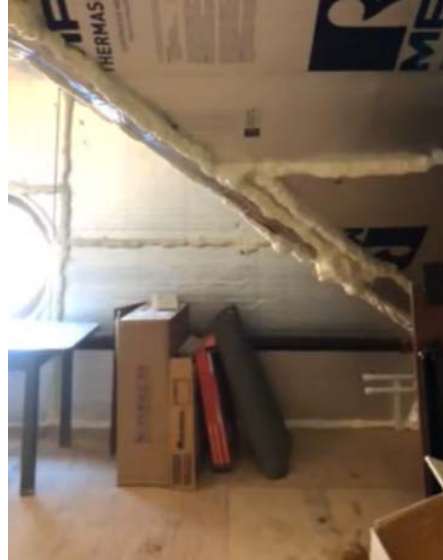
Town Hall Attic

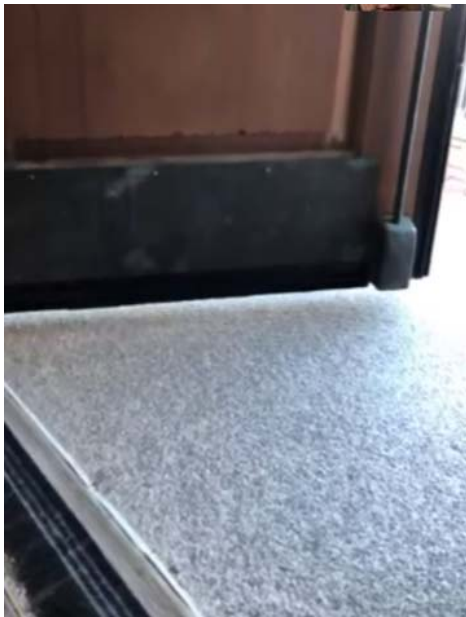
Town Hall Front Door

- Weatherstrip non-standard exterior door, 3’6” W x 7’ H, total 1 door
- Weatherstrip non-standard boiler room door, 3’6” W x 7’ H, using fire-rated materials, total 1 door
- Weatherstrip the front-entry, non-standard exterior wood doors, 2’6” W x 7’6” H, using spring-bronze type materials, total 2 doors

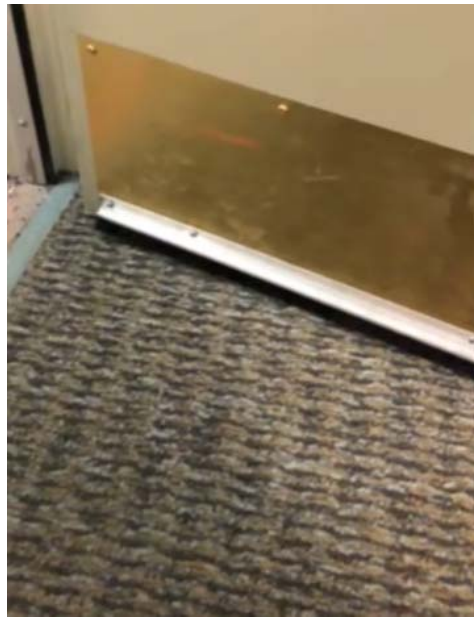
Town Hall Boiler Room Door

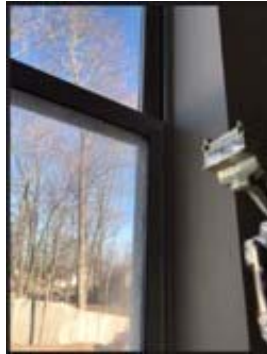
Public Safety Window

- Weatherstrip the WAT-2 units (double-channel on the left/right, single-channel on the top/bottom), **total 414 LF**
- Air-seal the WAT-1, WAT-2, and WAT-3 units along the frame-wall junctures, 1-line, using non-foam sealants, **total 482 LF**

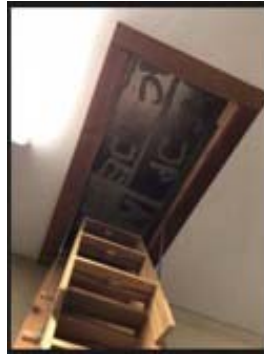
Public Safety Attic

- Install an effective air barrier affixing 1" fire-rated board insulation to the bottom of the truss framing, sealing seams with 2-component, closed-cell, polyurethane spray foam, total 3,895 SF

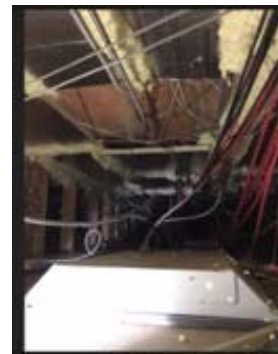
Public Safety Attic

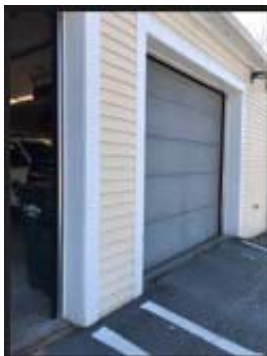
Public Safety Overhead Door

- Weatherstrip the 9' W X 8' H overhead doors, **total 2 doors**
- Weatherstrip the 12' W X 12' H overhead doors, **total 4 doors**

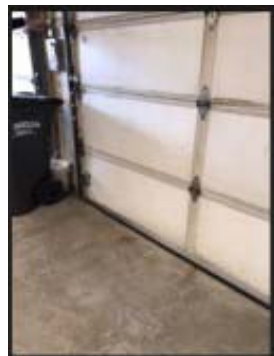
Public Safety Door
to Garage

- Weatherstrip standard-size exterior doors, **total 4 doors**

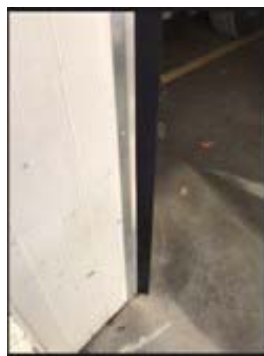
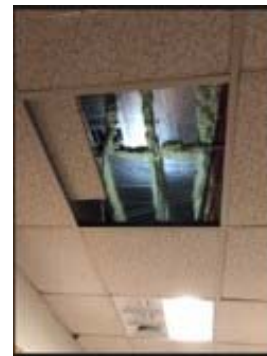
Public Safety Ceiling

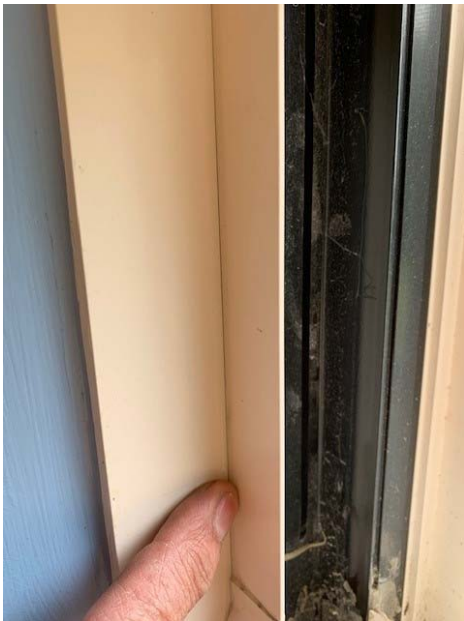
Penn Brook Window

- Air-seal the WAT-1 and WAT-4 to WAT-10 units along corners where the mullions join, 1-line, using non-foam sealants, **total 708 LF**

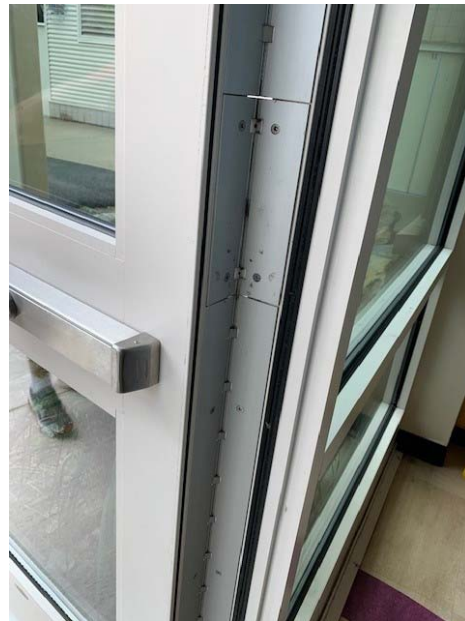
Penn Brook School Door

- Weatherstrip standard-size exterior doors, total 17 doors
- Weatherstrip non-standard exterior door, 3'6" W x 7' H, total 1 door
- Weatherstrip non-standard exterior door, 4' W x 7' H, total 1 door
- Weatherstrip non-standard exterior doors, 3' W x 8' H, total 8 doors
- Weatherstrip standard-size mechanical room door using fire-rated materials, total 1 door

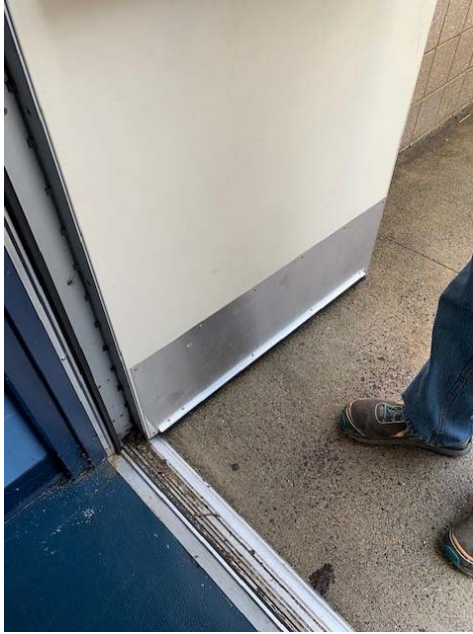
Penn Brook School Boiler Room Door
